Revolutionary long-distance CCTV inspections

by Kobus Prinsloo, SSISS

SSIS Sahara recently performed the first long-distance CCTV inspections under live operating conditions in South Africa on the Vaal Gamagara Water Scheme in the Northern Cape.

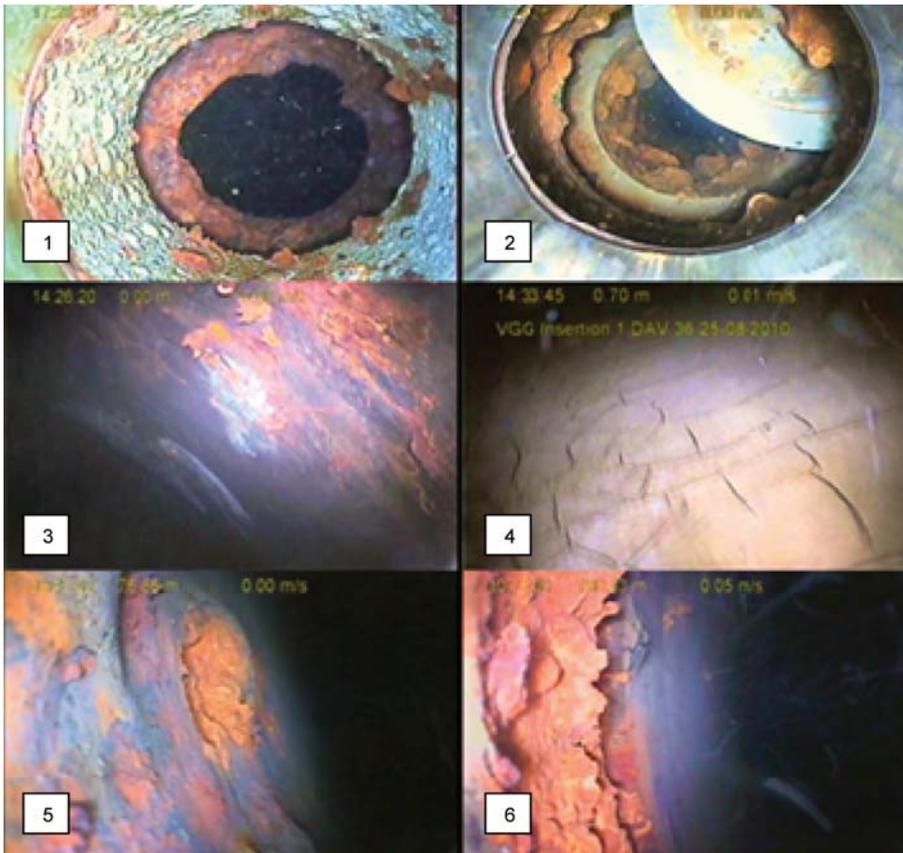
condition of the selected pipe sections (refer to figure 4). Apart from observations of normal bio-film growth inside the pipelines, the following findings were documented:

- gate valve condition, riser stub corrosion and tuberculoses
- damaged and defective lining, including cracked lining, damaged or missing lining, visible signs of corrosion product build-up, blistered lining and physical obstructions inside the pipelines

FIGURE 4: Selection of images captured inside the pipelines, showing: (1) early stages of riser stub corrosion (2) riser stub tuberculoses and condition of the gate valve disc (3) corrosion product build-up on the pipe wall (4) cracked lining (5) severe blistering of the pipe lining and (6) pipe joint corrosion
